USING NDT METHODS IN MARINE COMPOSITE STRUCTURES – CASE STUDIES

Non-destructive testing (NDT) is gaining increasing importance in the marine industry, with its application expanding beyond aviation into composite yacht manufacturing. This paper presents selected case studies using ultrasonic pulse-echo, infrared thermography, and laser shearography, performed on representative GFRP samples as well as real-world marine structures. The discussed examples highlight the challenges specific to thick composite sections, diverse defect locations, and the need for image-based evaluation systems. The selected cases address problems encountered by yacht manufacturers and attempt to indicate possible solutions.

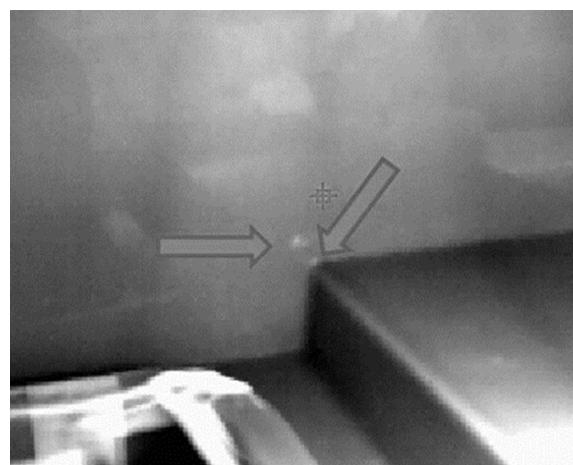
The first of these, recommended by specialists, was infrared thermography [10]. Inspection was performed on a deck with a complex shape. Due to the complex geometry, manufacturing defects were expected. According to the reference [10], the minimum detectable blister size is 6 mm. Nonetheless, this value is only an approximation since detectability depends on several factors such as gelcoat thickness, camera resolution, and the distance between the camera and the hull. In the presented tests, blisters with diameters of approximately 4–6 mm were successfully detected within an observation area about 1 m wide (Fig. 5). The inspection was performed using CCheck-IR equipment with IrNDT software.

Fig. 5. Thermography results. Bright spots marked by arrows are blisters

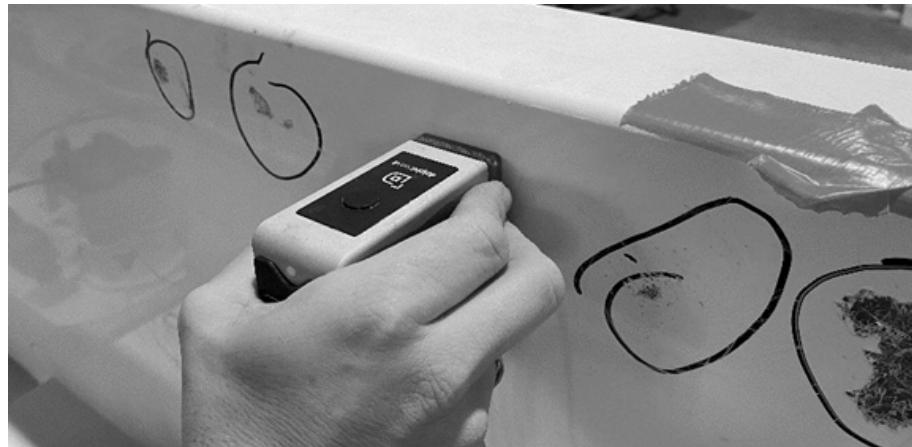
MHz and 5 MHz phased array probes. Because ultrasonic inspection is more time-consuming than thermography, this method was applied to areas where numerous blisters had been detected visu-

Fig. 6. Inspected area. Left and right side of probe are areas with visually detected blisters

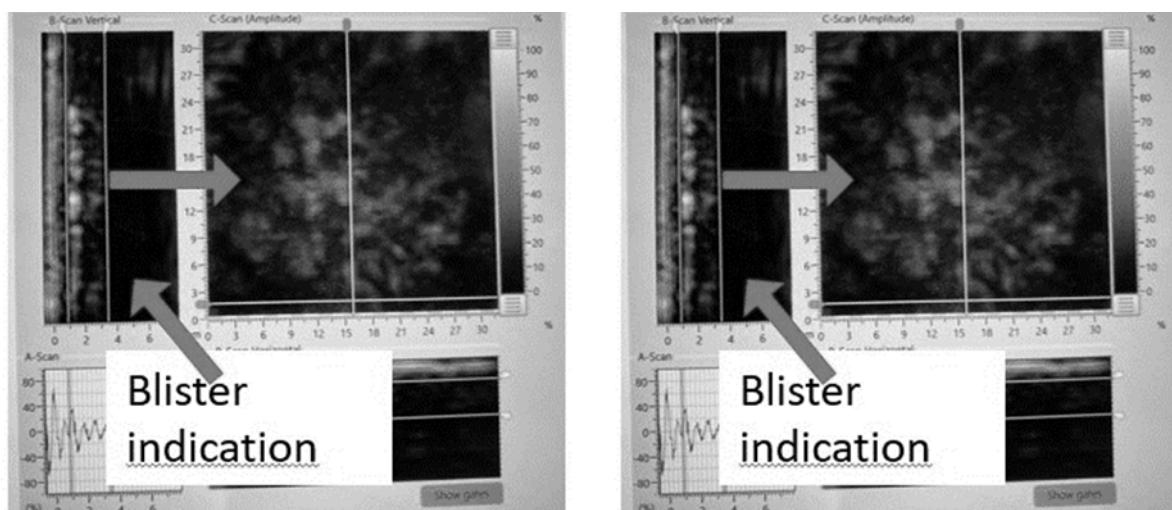
ally (see Fig. 6). Both the selected ultrasonic frequencies enabled the detection of blisters located on the underside of the gelcoat layer (Fig. 7).

Fig. 7. Ultrasonic indications of about 20 mm diameter blister. 2.5 MHz result left, and 5 MHz result right

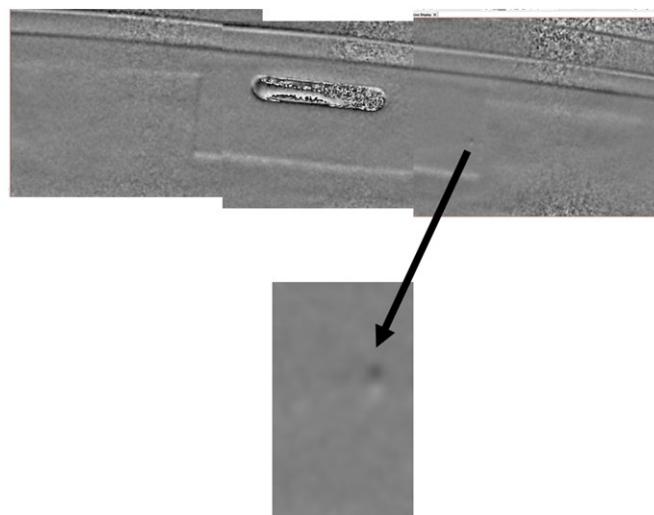
hull was examined. Deformation state changes were induced by heating lamps, and the detected defect size was approximately 6 mm (Fig. 8).

Fig. 8. Blister detected on hull by using laser shearography method

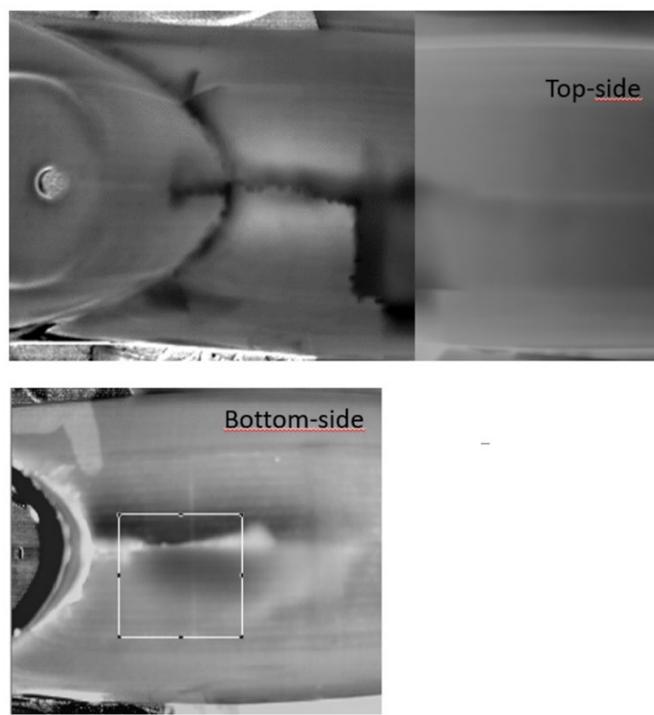
The second case concerned damage identification for repair purposes. The bowsprit of a racing yacht had been damaged during a collision. During visual inspection, a small defect was observed on the upper side of the bowsprit. Since the CFRP structure is opaque, the full extent of the damage was unknown and detailed NDT was required. Two methods were applied.

The first method was infrared thermography, which allowed assessment of the damage size and provided a relatively fast means of evaluating other areas of the component. The inspection was carried out using CCheck-IR equipment. As a result, several delaminations caused by the collision were detected on both the upper and lower sides of the bowsprit. The results are presented below (Fig. 9).

Fig. 9. Results of thermography tests of upper and lower surface of bowsprit. Extensive damage is visible on both surfaces

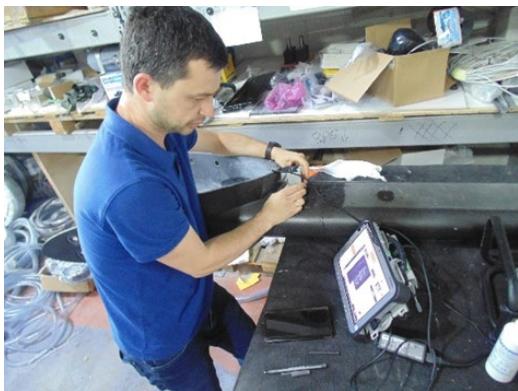
Fig. 10. Ultrasonic inspection

However, due to the limited depth of penetration of thermography, the depth and size of the detected damage were difficult to quantify accurately. Based on the thermographic results, a UT phased array inspection was performed to determine the exact extent of the damage. The inspection was carried out employing DolphiCam2 equipment with a 2.5 MHz probe (Fig. 10).

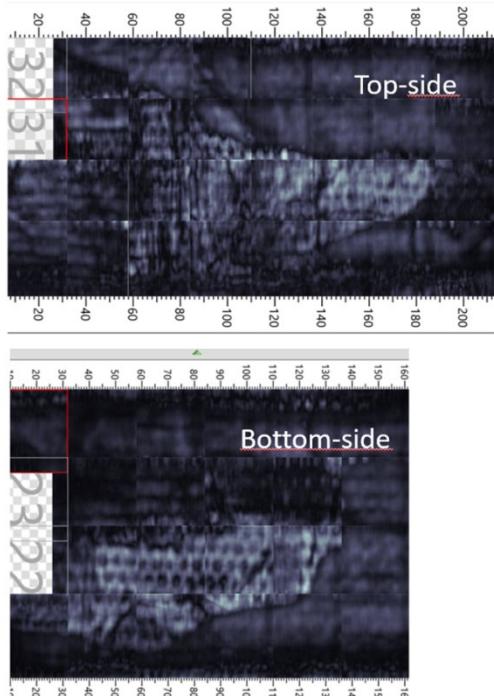
Fig. 11. Ultrasonic C-scans

Using current C-scan results, the damage boundaries were marked directly on the bowsprit in a step-by-step manner (Fig. 11). Additionally, a stitched amplitude map was generated to visualize the damaged areas.

Damage sizing was later confirmed during the composite repair process, and the repaired component was subsequently reinstalled on the yacht.
