USING NDT METHODS IN MARINE COMPOSITE STRUCTURES – CASE STUDIES

Non-destructive testing (NDT) is gaining increasing importance in the marine industry, with its application expanding beyond aviation into composite yacht manufacturing. This paper presents selected case studies using ultrasonic pulse-echo, infrared thermography, and laser shearography, performed on representative GFRP samples as well as real-world marine structures. The discussed examples highlight the challenges specific to thick composite sections, diverse defect locations, and the need for image-based evaluation systems. The selected cases address problems encountered by yacht manufacturers and attempt to indicate possible solutions.

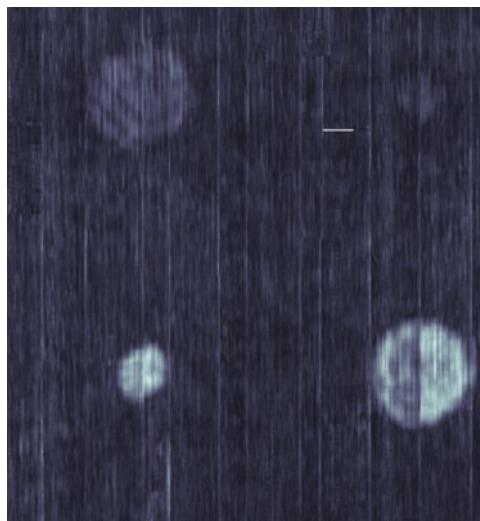
The ultrasonic testing (UT) method is particularly sensitive to porosity, voids, impact damage, and disbonds. A significant advantage of UT is its ability to detect defects located relatively deep beneath the surface. Figure 2. presents the results of UT phased array testing performed on a reference specimen (Fig. 1) using DolphiCam2 equipment.

Fig. 2. Results of ultrasonic phased array test of sample from Figure 1

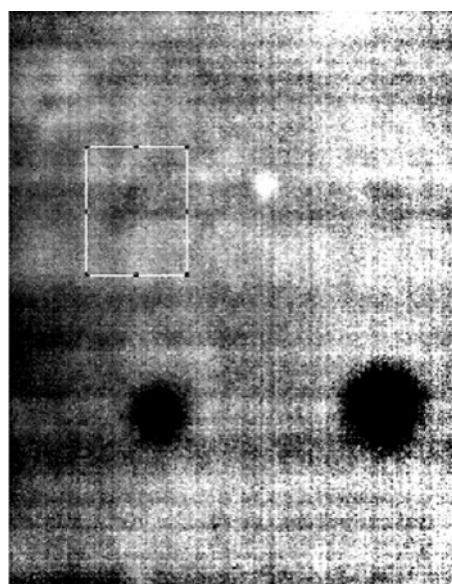
The relationship between the actual defect size and its thermal indication depends on both the defect depth and the thermal properties of the material. Specific techniques such as flash thermography are best suited for thin laminates, whereas pulsed phase thermography can be applied to thicker laminates, though increasing thickness significantly reduces the signal-to-noise ratio (SNR) [11]. On the examined sample, it was possible to obtain clear indications from the flat-bottom holes at a depth of 8 mm, and almost invisible indications from the holes at the same depth that were filled with resin (Fig. 3).

Fig. 3. Result of thermographic test of sample from Figure 1

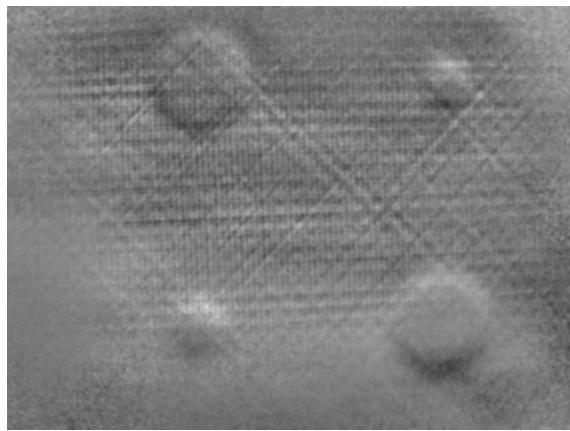
Like thermography, shearography is a contactless and real-time NDT method. The principle of the technique is based on laser interferometry. A coherent laser beam is expanded to generate a speckle pattern on the illuminated surface. This pattern of scattered light is reflected from the surface and captured by a CCD camera utilizing an image-shearing device [12, 13]. After the object undergoes slight deformation, a second set of images is recorded. The difference between the two captured states enables the reconstruction of an interference fringe pattern that represents the displacement derivatives. Shearography is highly sensitive to out-of-plane surface displacements [14]. Defects detected by this method are primarily associated with local stiffness variations, such as disbonds, delaminations, core damage, or moisture ingress. To induce measurable surface deformation, shearography requires an external excitation source, most commonly heating by halogen lamps or the application of vacuum pressure. When using thermal excitation, the indications should be interpreted with caution. In this case, the two upper round indications come from the resin-filled holes, and with the applied approach, they do not differ from the indications from the flat-bottom holes modeling delaminations (Fig. 4.)

Fig. 4. Result of laser shearography test of sample from Figure 1
